Report on the viability of onsite ditch as a river over Map 4 Lot 5

1530 Fall River Avenue, Seekonk, MA

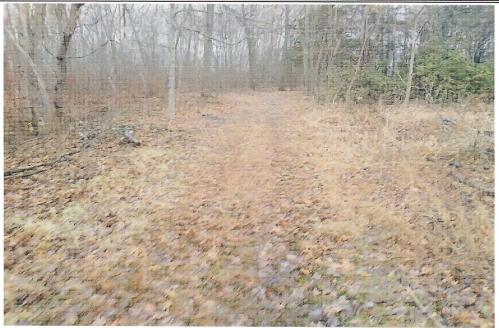
1 Cart Path

At the rear of the site is a farm field on Map 4 Lot 46, 78 Wheaton Avenue and the ditch in question appears to terminate at the edge of that field. It may be collecting water from the wetland area to the west, but the defined depression of the ditch "peters out" at the edge of the field and does not directly connect to any other water body or depression. Similarly at the southerly end of the ditch the depression terminates and does not appear to connect to any other water body or depression. There is a pond to the east and it is possible that the ditch may have connected to it in the past but there is currently no sign of a connection and no sign of flow. The ditch terminates at the westerly edge of a cart path that connects fields on Lot 46 to Lot 5. No pipes or conduits were found under the cart path. Review of aerial photos on Google Earth show that cart path dates back to at least 1995, or possibly earlier.

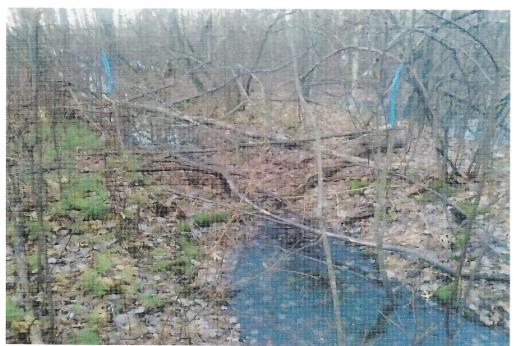
2 High Spot

No flow or movement of water was found in the ditch during any of the site observations. A high spot was observed approximately mid way along the ditch where water was never present. The high spot occurred between wetland flag S-A11 & S-B10. A photograph of the high spot from January 6, 2022 along with a photo of the cart path from December 30, 2021 is included at the end of this report.
